Technical Service Handbook

Model description: LEON 1.5 TSIFR 5d110 DS9M6

4545, KL, KU, KM7: Irregular operation of the electric parking brake with the Autohold or EPB activated

Transaction No.: 2063188/6

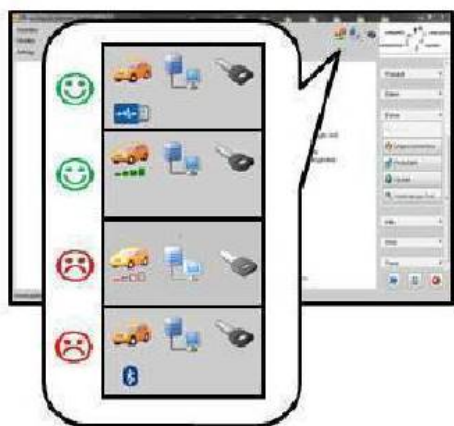
The software configuration (SVM) can be done both with a USB cable and via WiFi if the signal is strong enough. If the WiFi signal is not strong enough a note is displayed (see Figure 1), and the USB cable must be used. The use of Bluetooth is still currently not allowed. Before connecting the USB cable, remove the diagnostics unit radio communication terminal! If the USB cable is connected while the radio communication terminal is attached, the communication will be established via Bluetooth.

**Figure 1:** Example of the information icons when there is sufficient or insufficient signal via WiFi / Bluetooth.
