Technical Service Handbook

Technical product information

Update of software packages (baselines)

Transaction No.: 2066692/3

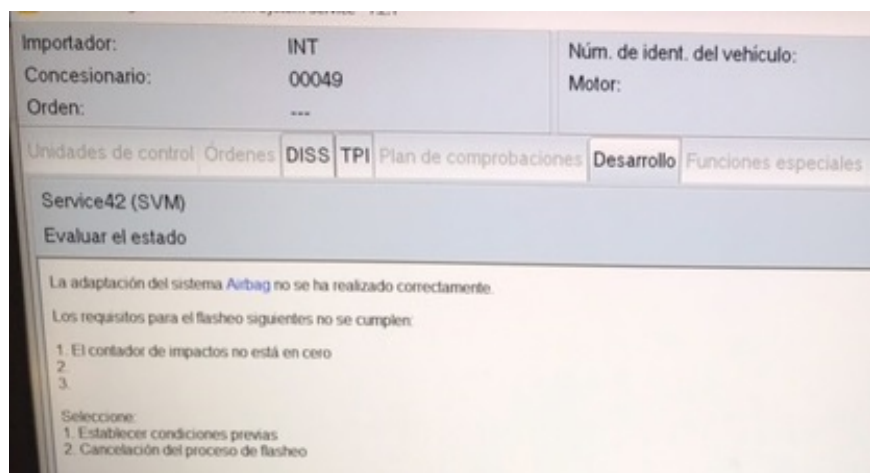
Figure 8: Example of the diagnostics equipment screen.

Indication 2: The Airbag control module 0015 does not allow the software to be updated.

In certain cases, the Airbag control module with SW 0036 detects that the impact counter is not at zero and does not allow it to be updated.

- To resolve this error, the Airbag control module 0015 must be replaced.
