Technical Service Handbook

Technical product information

Update of software packages (baselines)

Transaction No.: 2066692/3

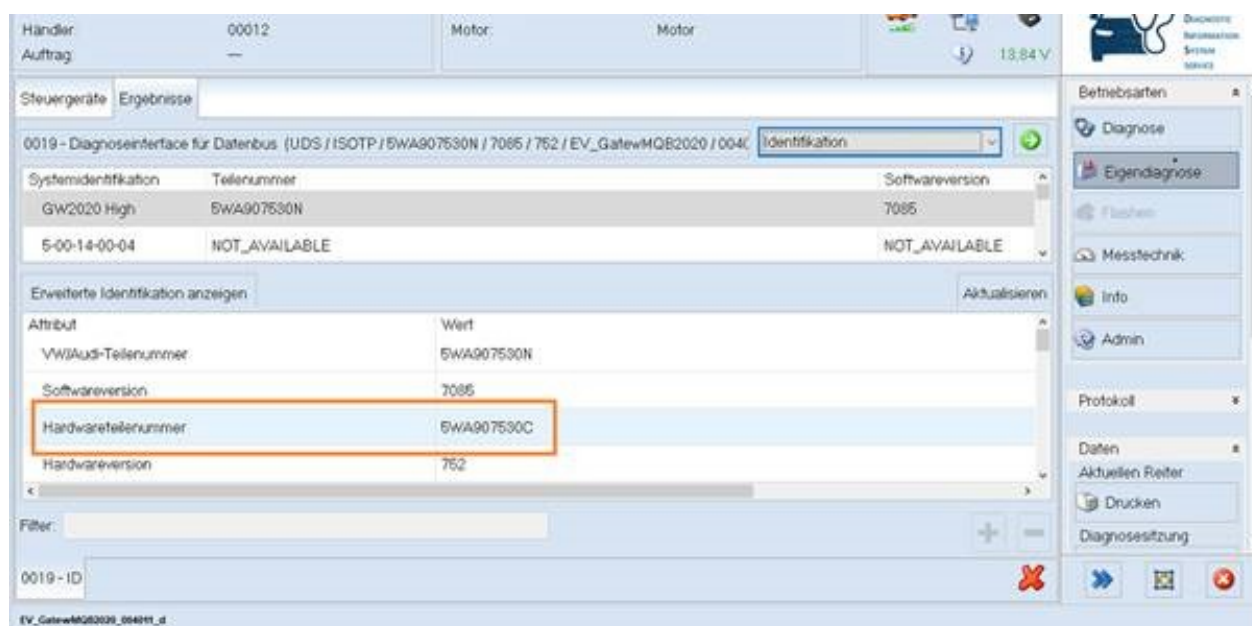
- The **hardware part number** that is currently installed can be checked with the vehicle diagnostics equipment as described below.
 - Self-diagnosis
 - 0019 Data bus diagnosis interface
 - Identification
 - Check the hardware part number of the data bus diagnosis interface control unit (see Figure 1, orange rectangle)

Figure 1: As an example: Checking the hardware part number of the data bus diagnosis interface control unit (diagnosis address: 0019)

- If a data bus diagnosis interface control unit with the hardware part number indicated above (with letter "**C**") is installed:
 - Continue to point: "**Regarding point 1.3**".

- The data bus diagnosis interface control unit must be changed for the one indicated in ETKA.

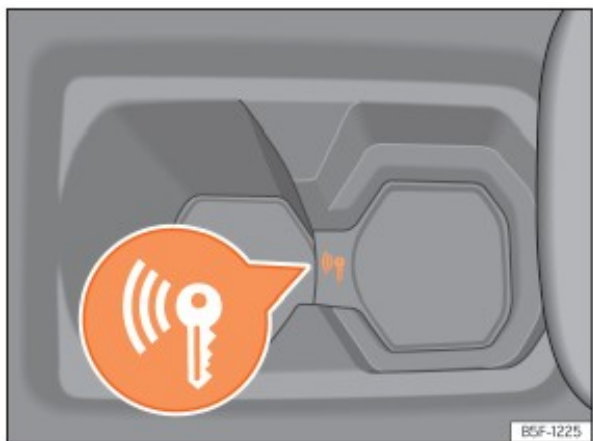
Figure 2: Vehicle without ignition lock (Kessy): Vehicle key placed in the centre console

- Open the driver door and the bonnet and leave them open while updating the software.
- Vehicles without an ignition lock installed (Kessy): Place the vehicle key in the centre console (in the reader coil) (see Figure 2).

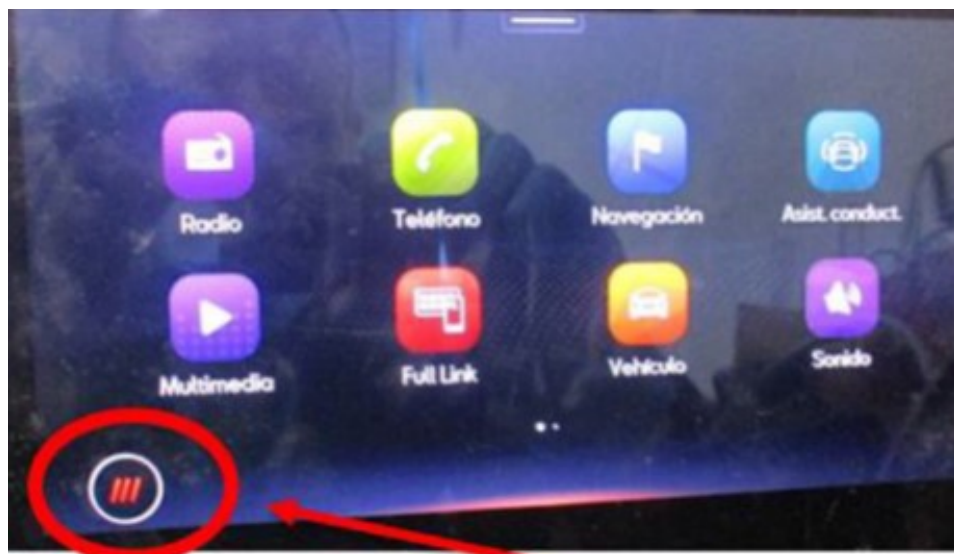
Figure 3: Press and hold the Menu/Home button on the control panel screen for about 5 seconds.

- Turn on the radio and navigation system. Please wait 5 minutes until all the functions of the devices have loaded.
- Remove/disconnect all USB connectors, charging cables, etc. from the USB interfaces.
- Connect/insert the "**USB stick**" (reference number: **5FA 919 360 S**) in one of the two USB interfaces (located above the storage compartment in the centre console).
- Press and hold the "**Menu/Home**" button for about 5 seconds. The service menu will open, see Figure 3, red circle.

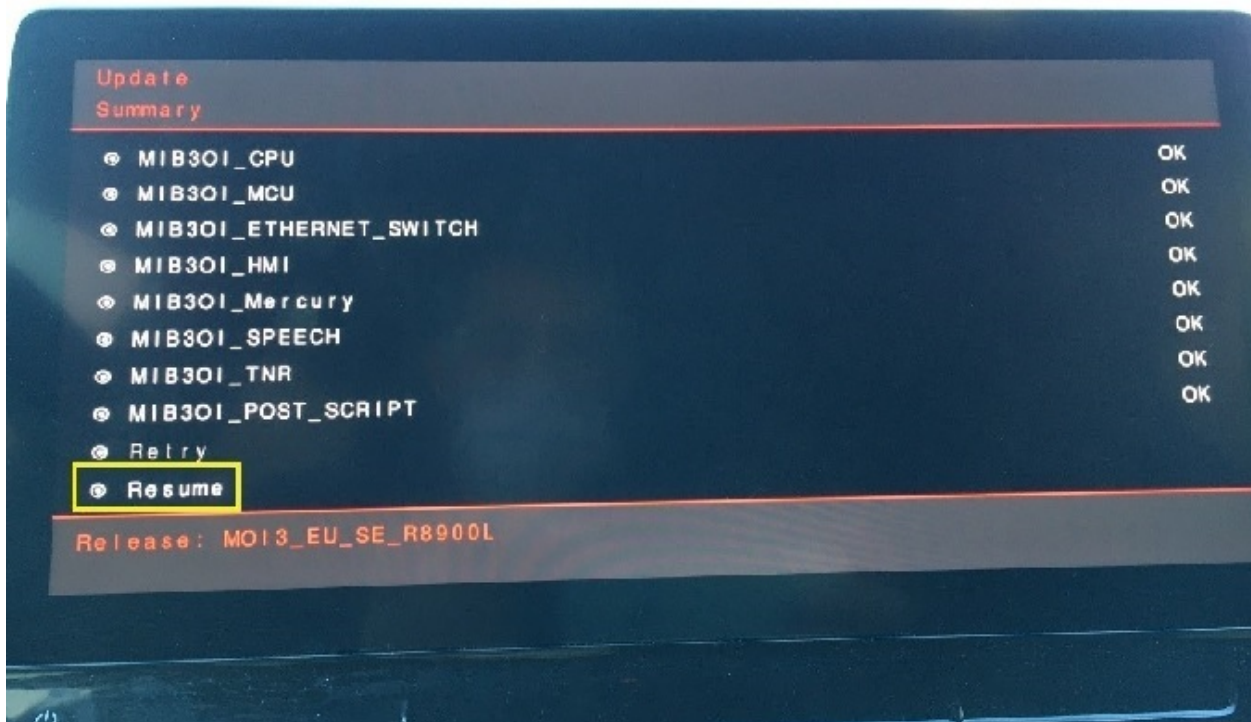
Figure 4: "Update Summary" of the radio and navigation system

- Press the button: "**Resume**" (see Figure 4, yellow rectangle).
- To finish the software update of the radio and navigation system, the following message is displayed: "**Software has been updated**".
- Confirm with the button: "**Accept**" (see Figure 5).

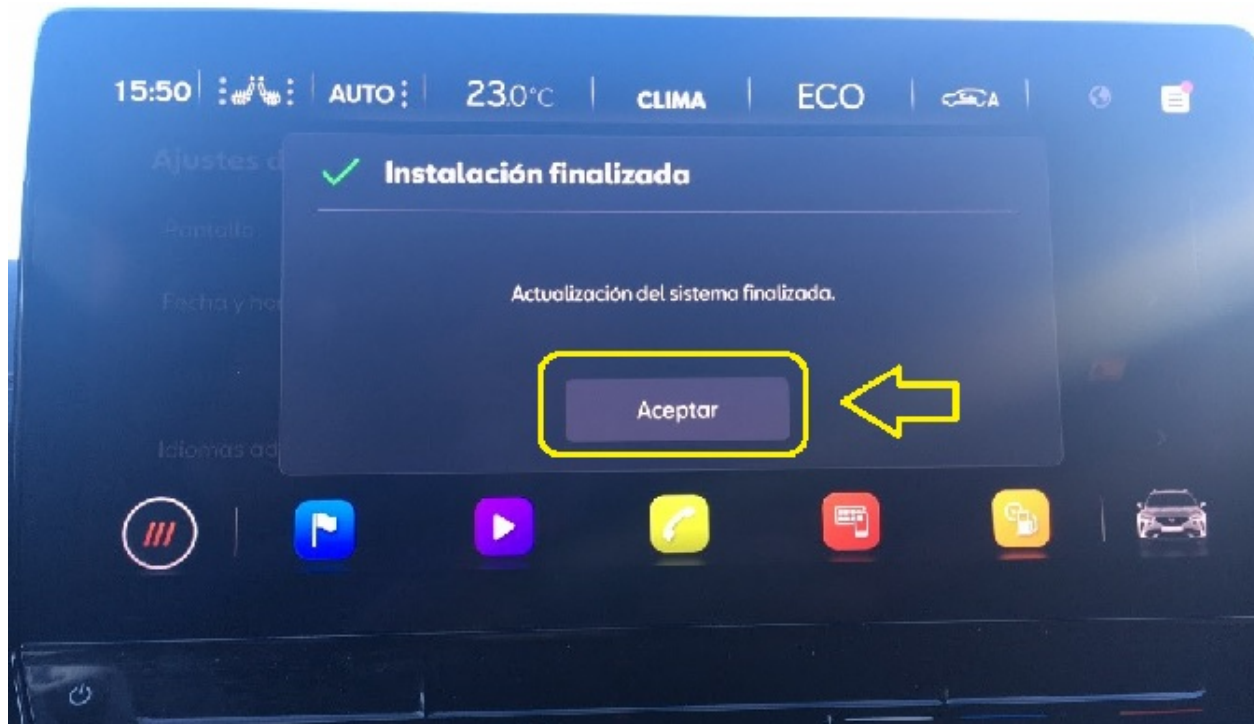
Figure 5: Finishing the software update of the radio and navigation system with the button: "Accept"

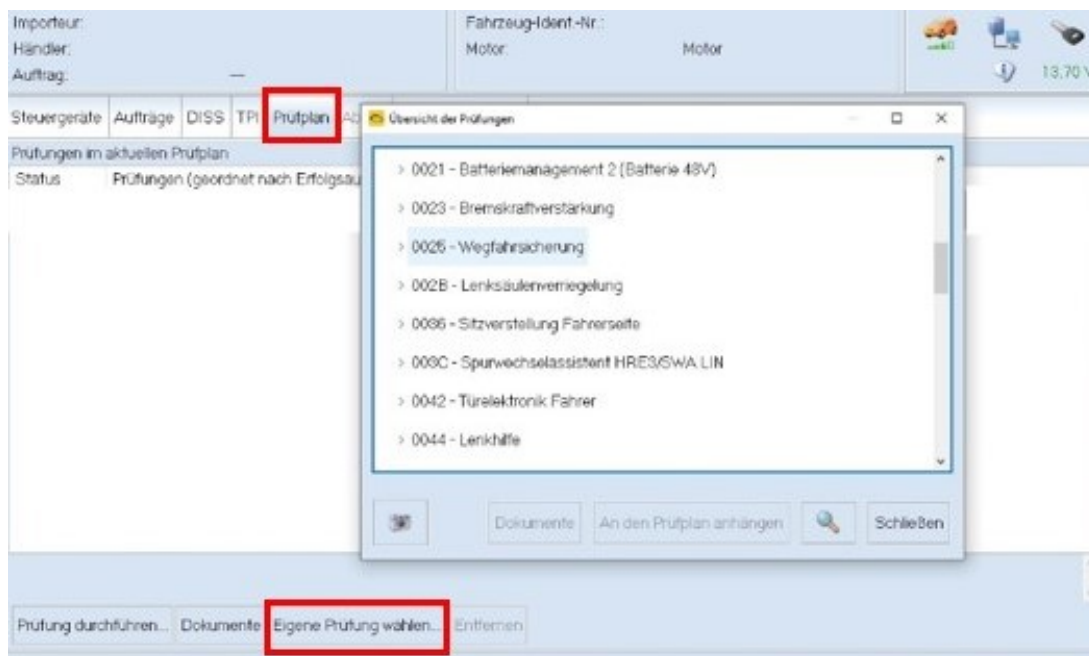
Figure 6: Test plan: Adapt the VKMS

- After the software update, perform the **"0025-VKMS Functions -> Adapt VKMS"** check.
- In the **"Test plan"** mode (see Figure 6, highlighted in red), select the function **"Select own check..."** (see Figure 6, highlighted in red).

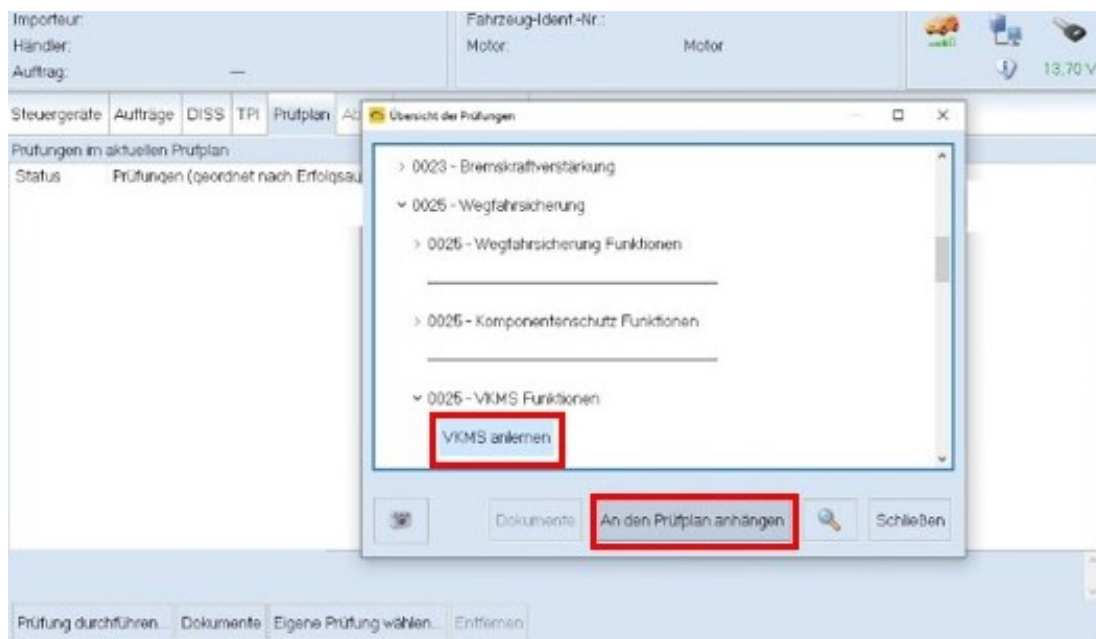
Figure 7: Test plan: Adapt the VKMS

- Select the check **"0025-VKMS Functions -> Adapt VKMS"** (see Figure 7, highlighted in red) and attach it to the test plan (see Figure 7, highlighted in red). **"Systems suitable for diagnosis" -> "0025 - Immobilizer" -> "0025 - VKMS Functions" -> "Adapt VKMS"**.
